ORNL-TM-627

REPORT ON FUEL-PLATE MELTING

AT THE OAK RIDGE RESEARCH REACTOR JULY 1, 1963

T. M. Sims
W. H. Tabor

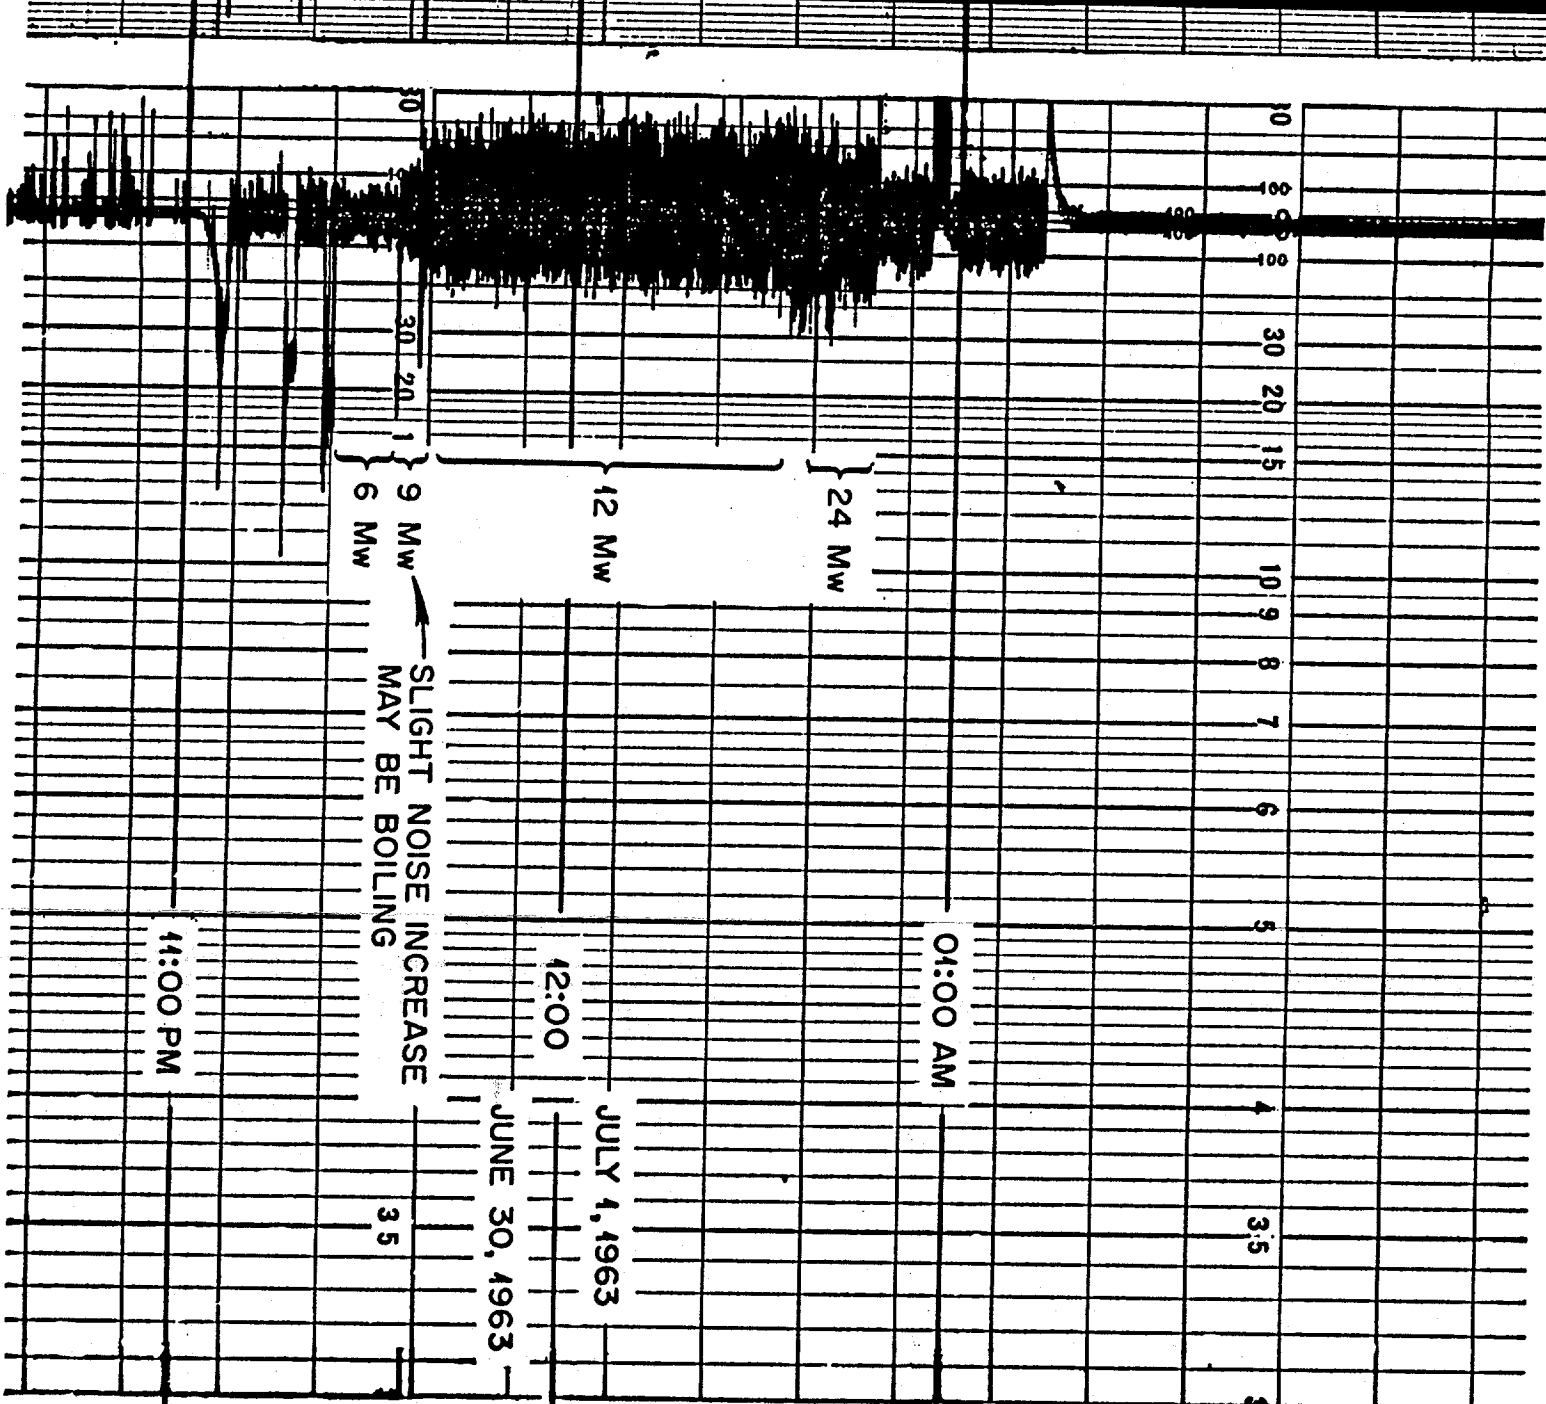
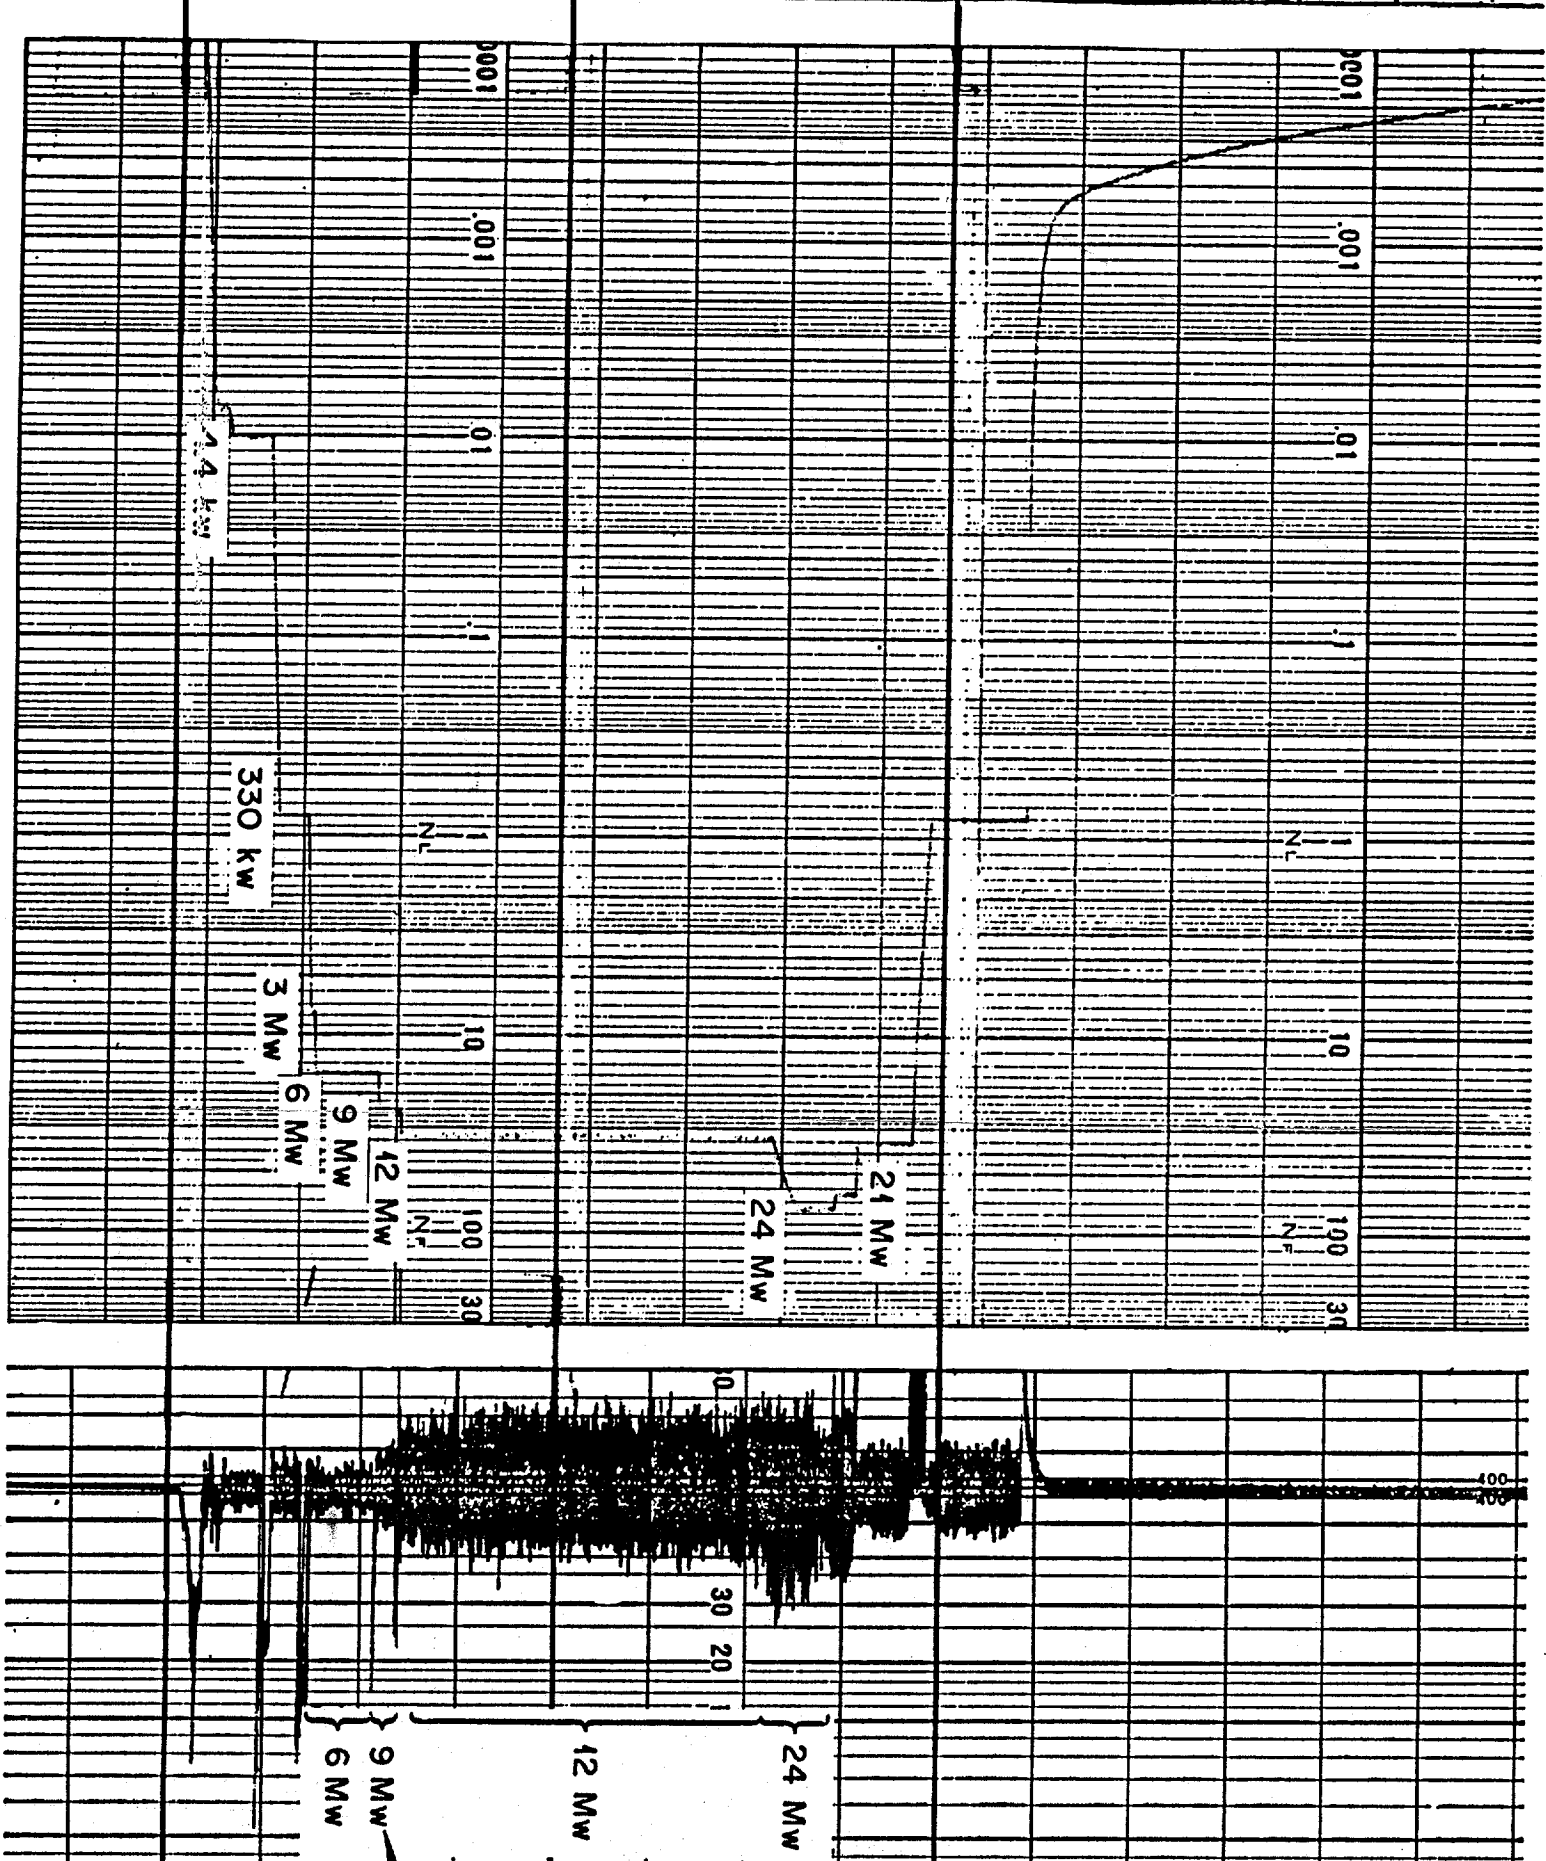
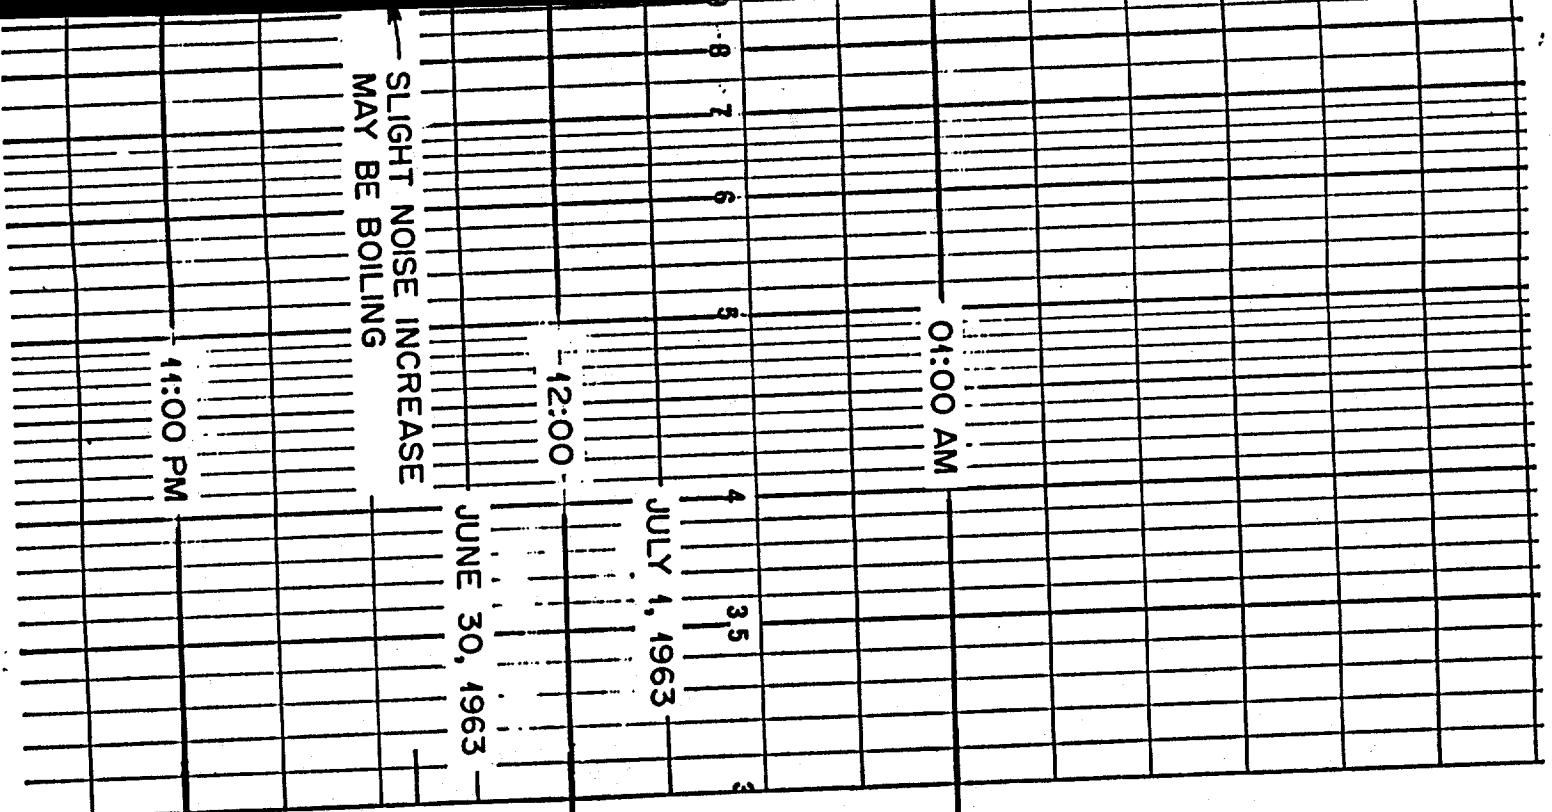
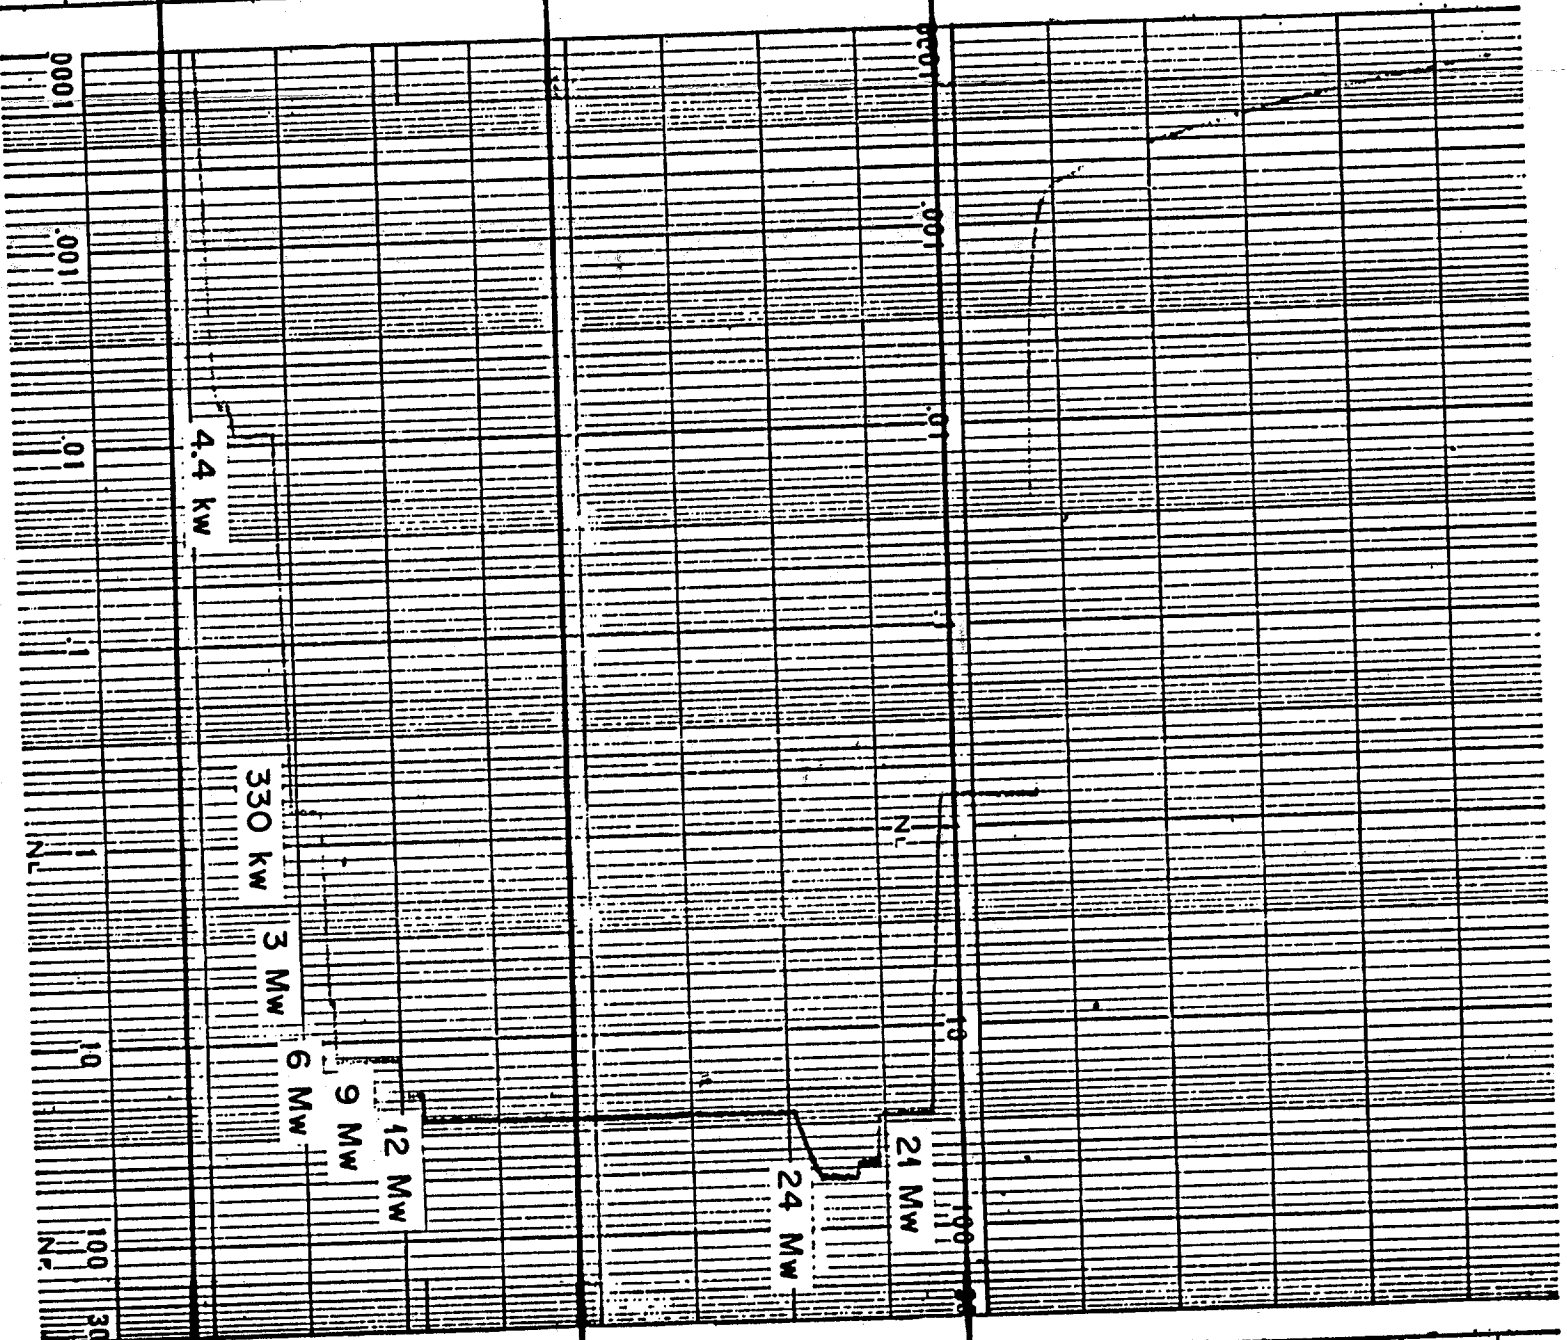
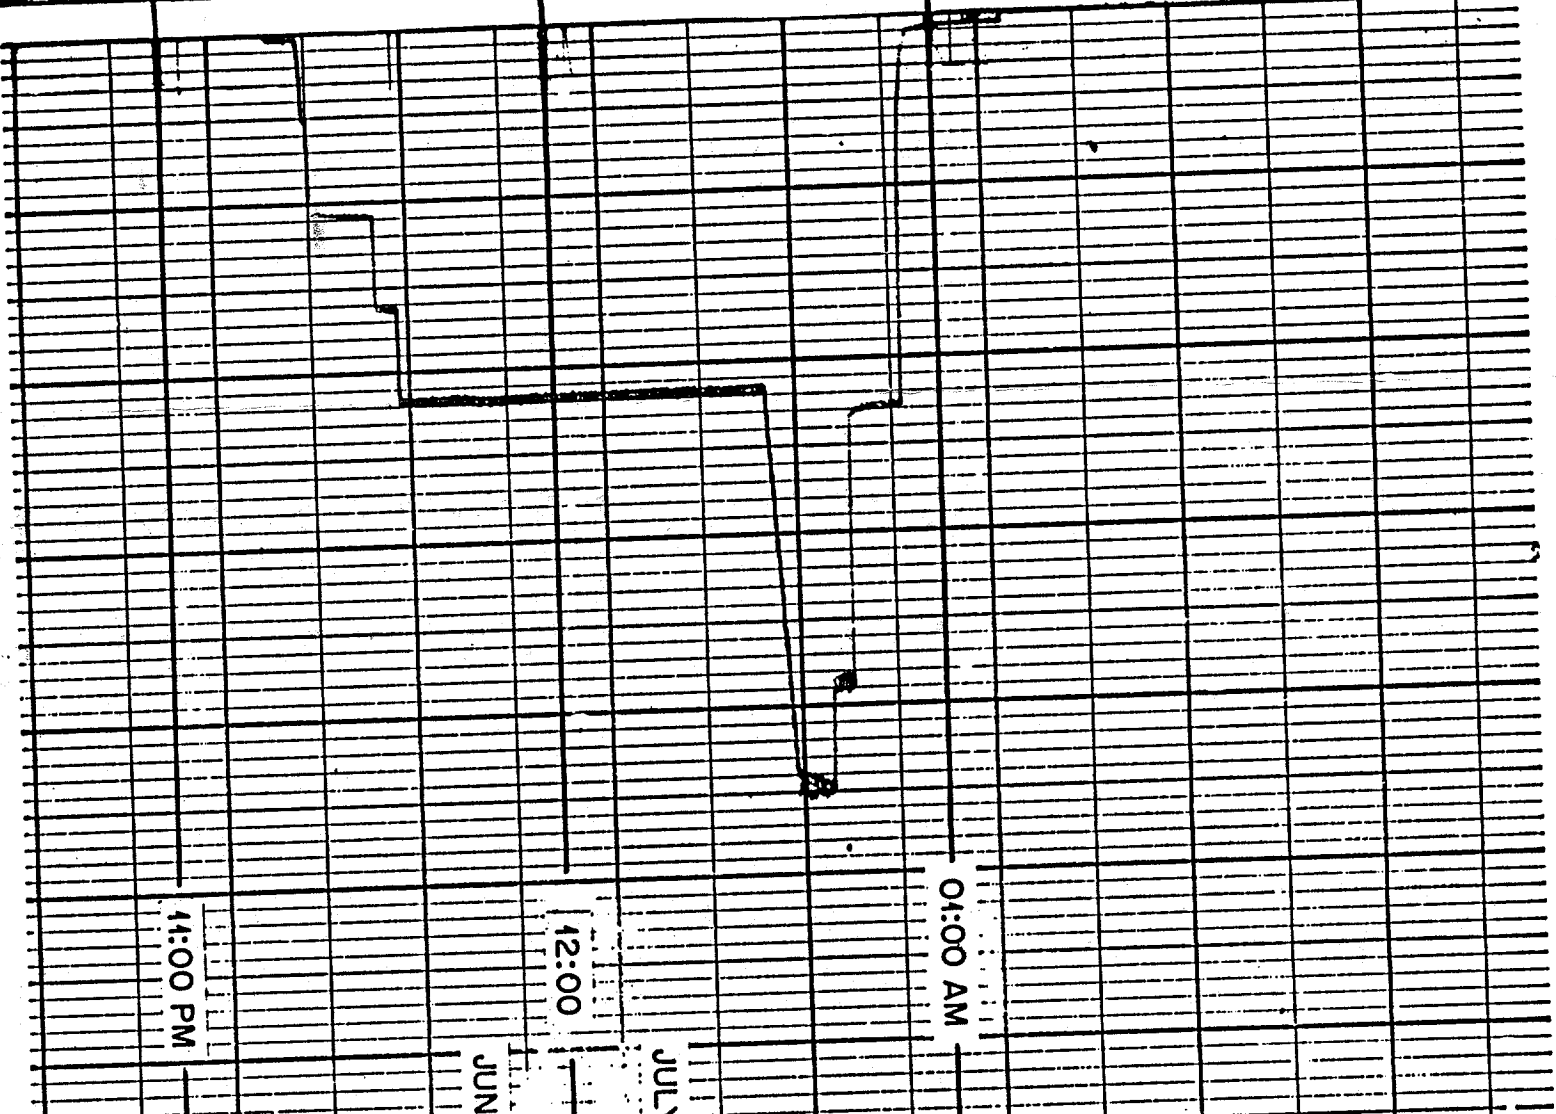
Fig. 1. Nuclear Instruments Recorder Charts from 10:30 PM, June 30, 1963, to 02:30 AM, July 1, 1963

At the 9-Mw step, everything seemed normal although postincident examination of the log-N period and safety channel charts indicates a slight increase of the reactor noise. This observation is interesting because, if one assumes that the blocked element started to boil at about 9 Mw, it indicates that it took an increase of a factor of 2.7 in power to damage the element. Accounting for possible variations in coolant flow, this corresponds quite well with heat-transfer predictions.

The power was then increased to 12 Mw, and there all instruments indicated some fluctuations. The servo system was also working harder than usual. These indications could only lead to two conclusions. The first is that the servo was out of adjustment and, therefore, excited the reactor; the second is that the reactor was noisier than usual and that the servo was trying to control the fluctuations. It would, of course, have been possible to decide between these two alternatives by putting the reactor in manual operation. If the noise remained, it could be concluded that the reactor fluctuated more than normally; if it vanished, the servo would have been at fault.

Consultation was held between the 4-12 and 12-8 shift engineers, and later a telephone consultation was held between the 12-8 shift engineer and an instrument engineer. The effect was attributed to the malfunctioning of the servo system. It must be recognized, however, that the amount of noise was not very large and that without comparing this chart with a chart from a previous cycle it is difficult to decide if the condition is really very abnormal.

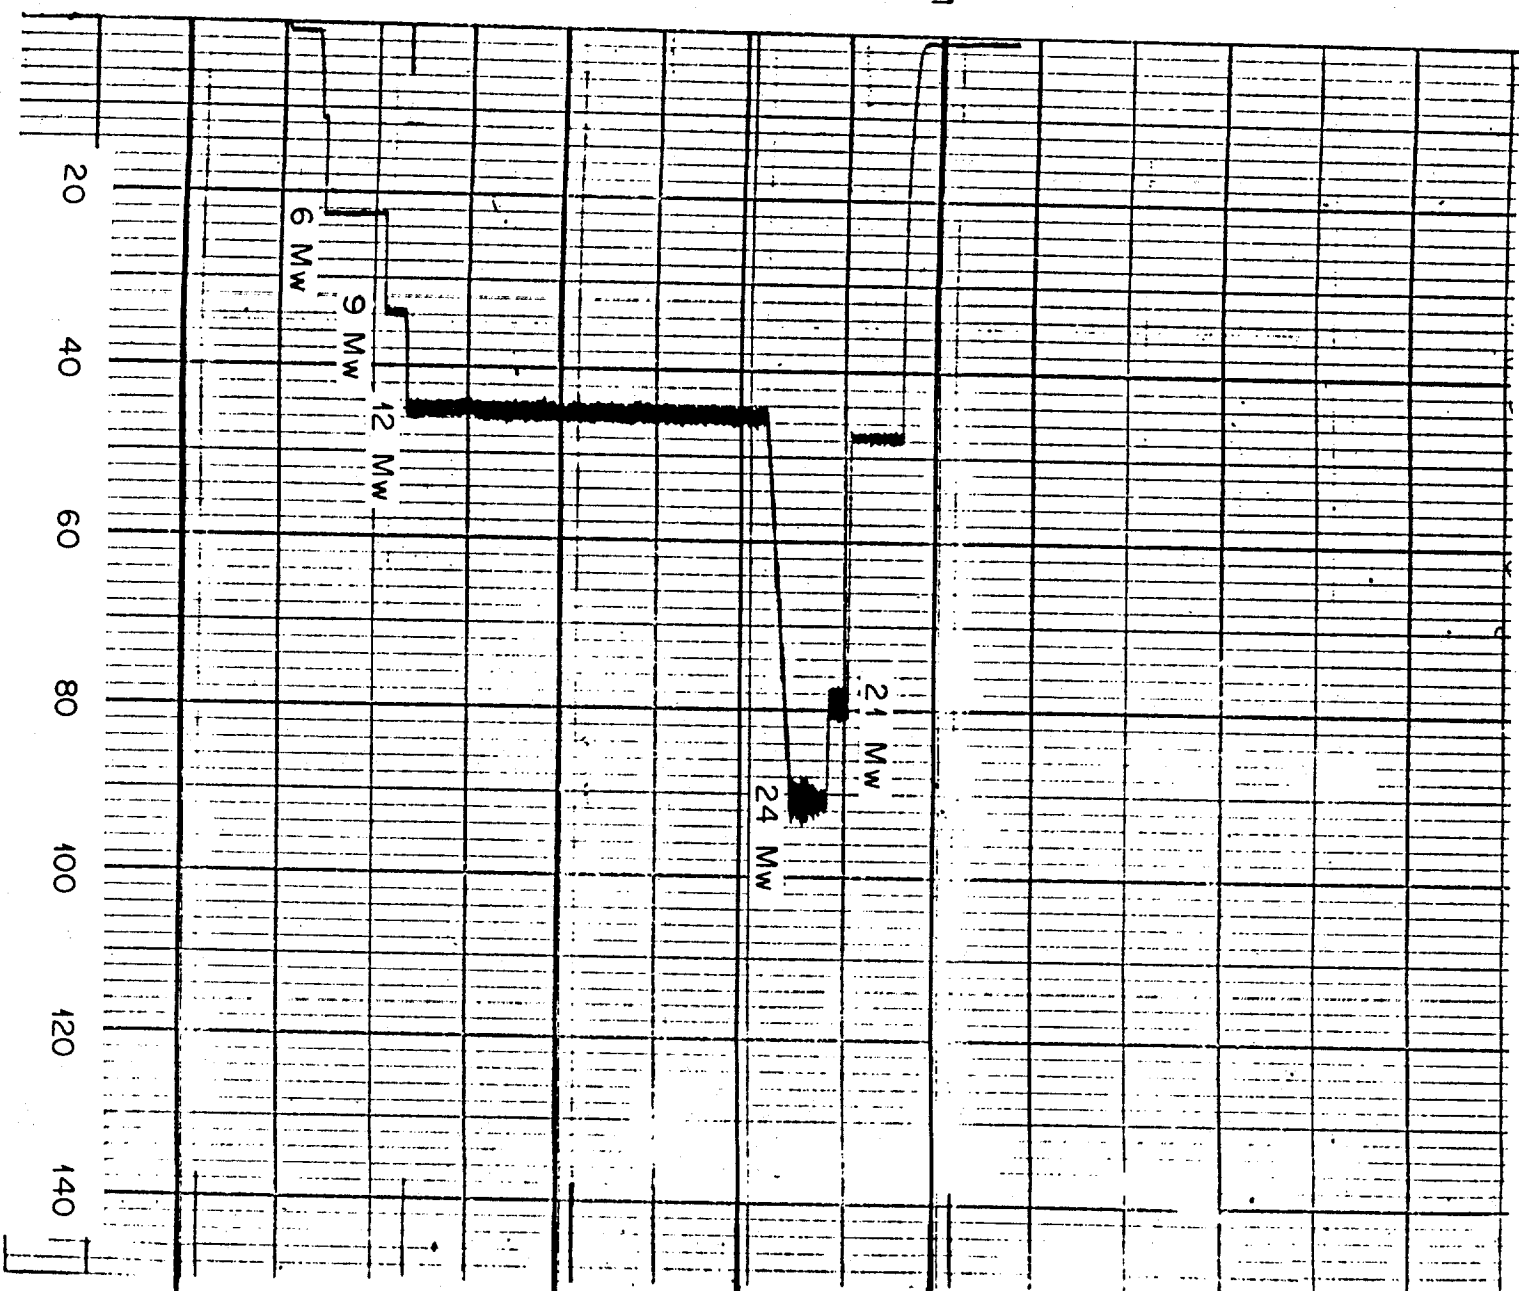
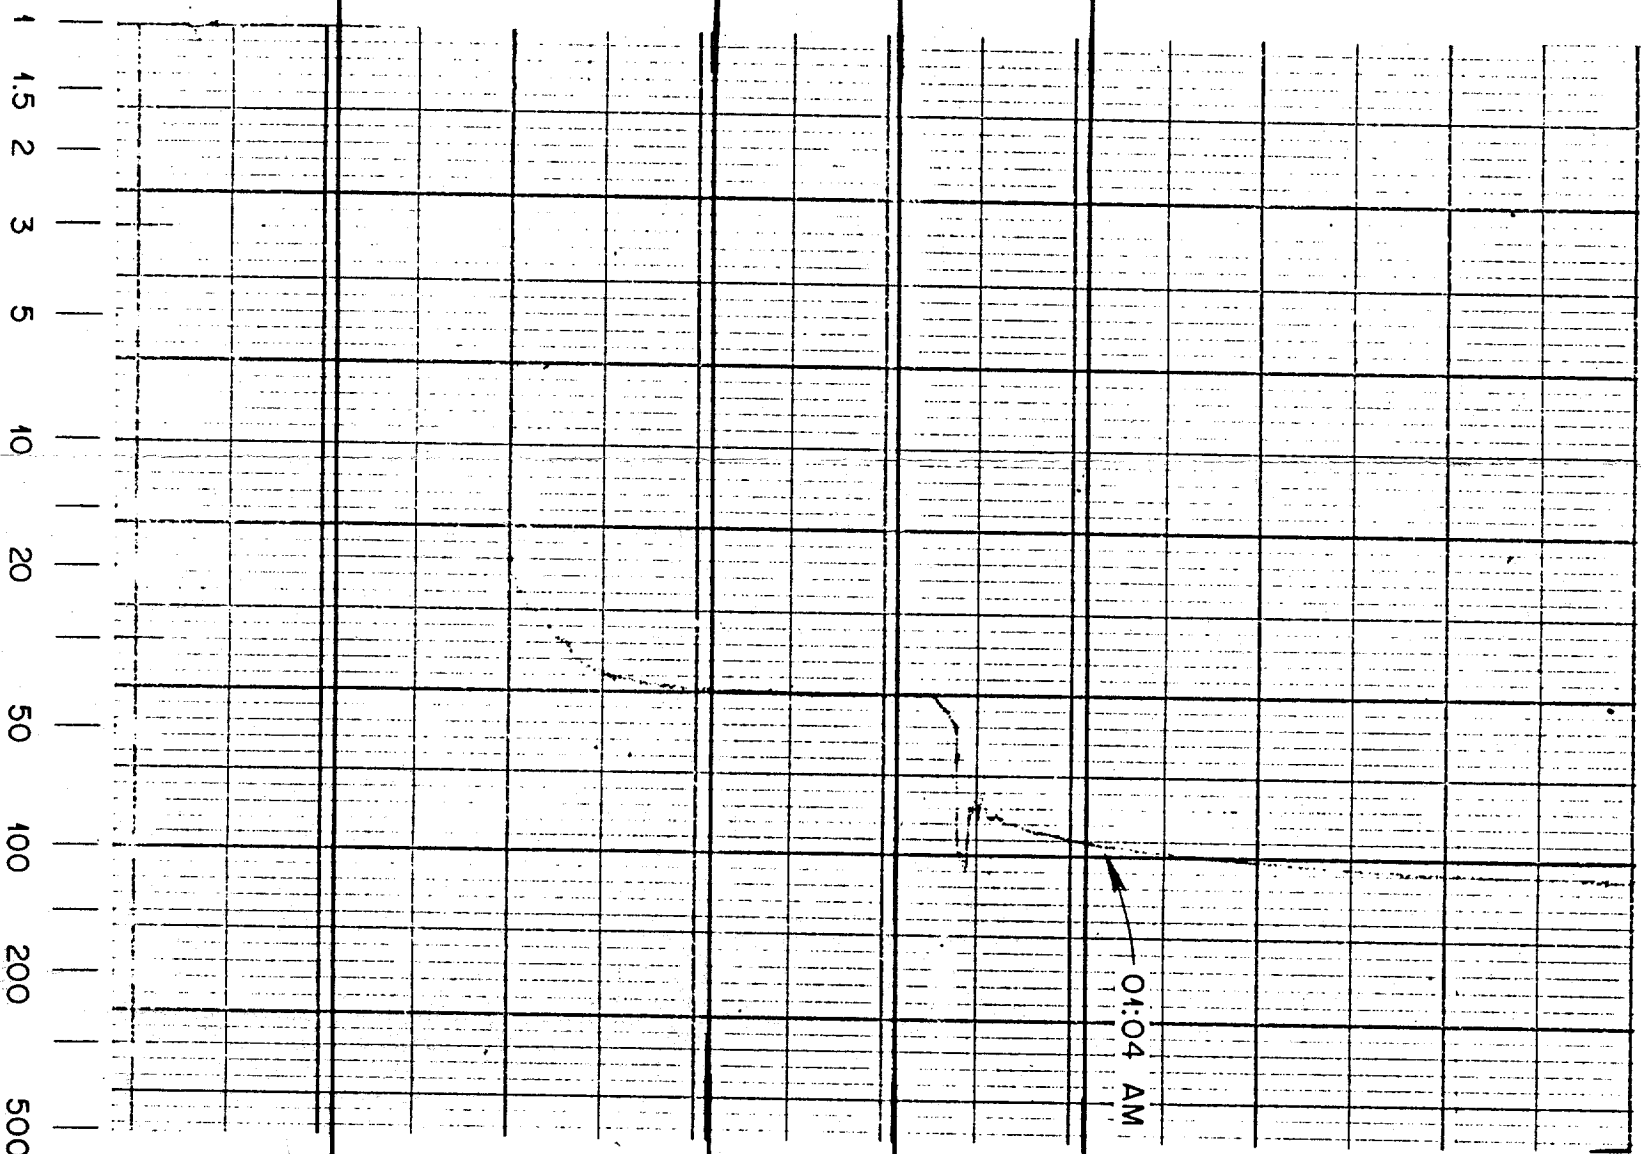
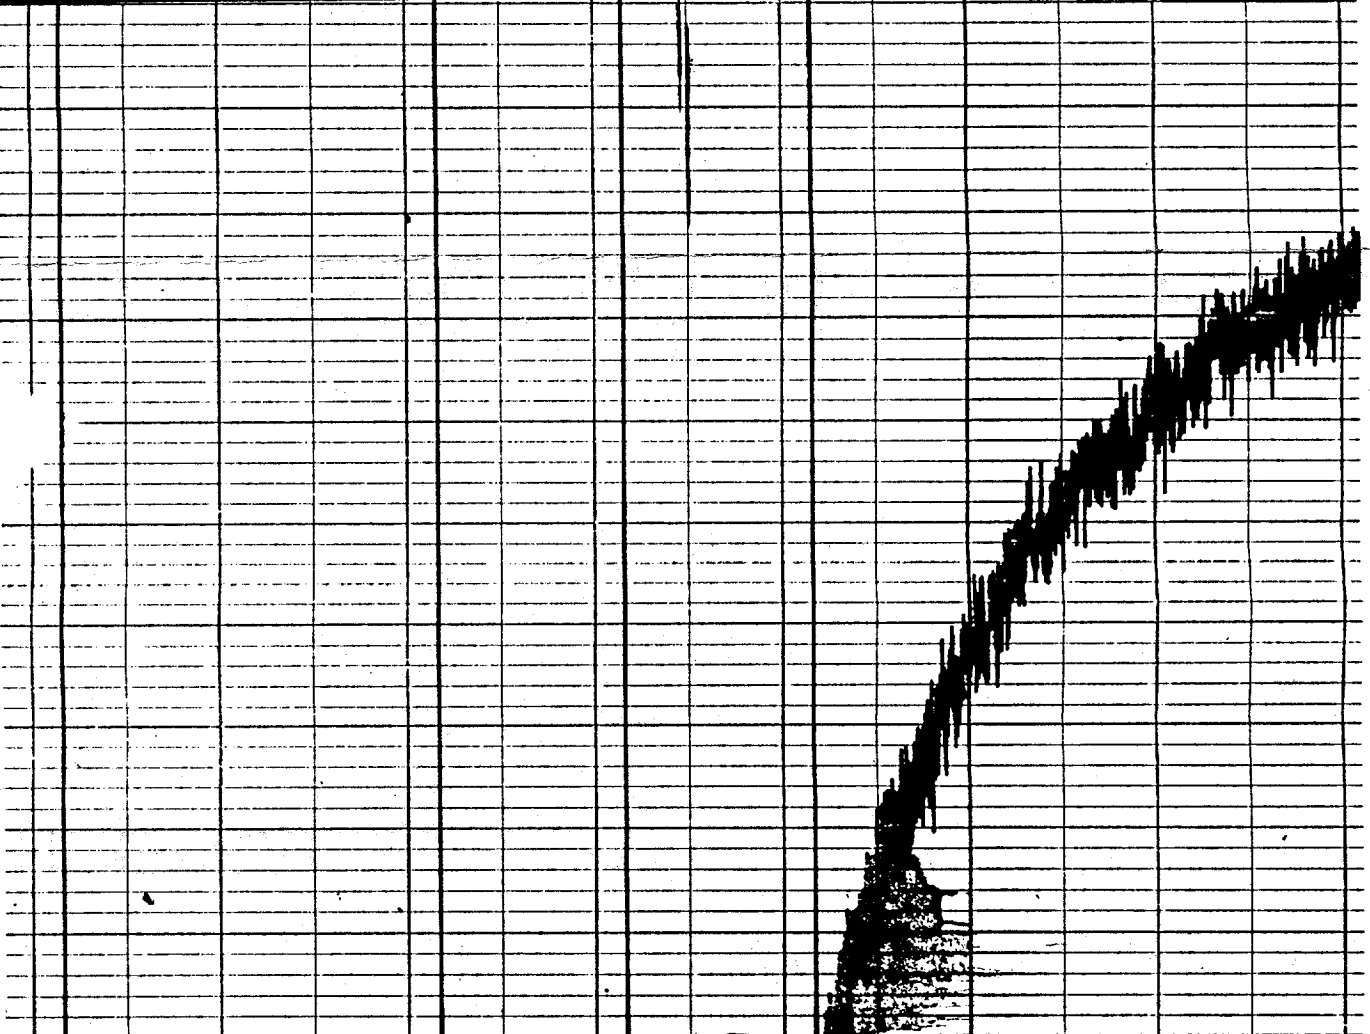
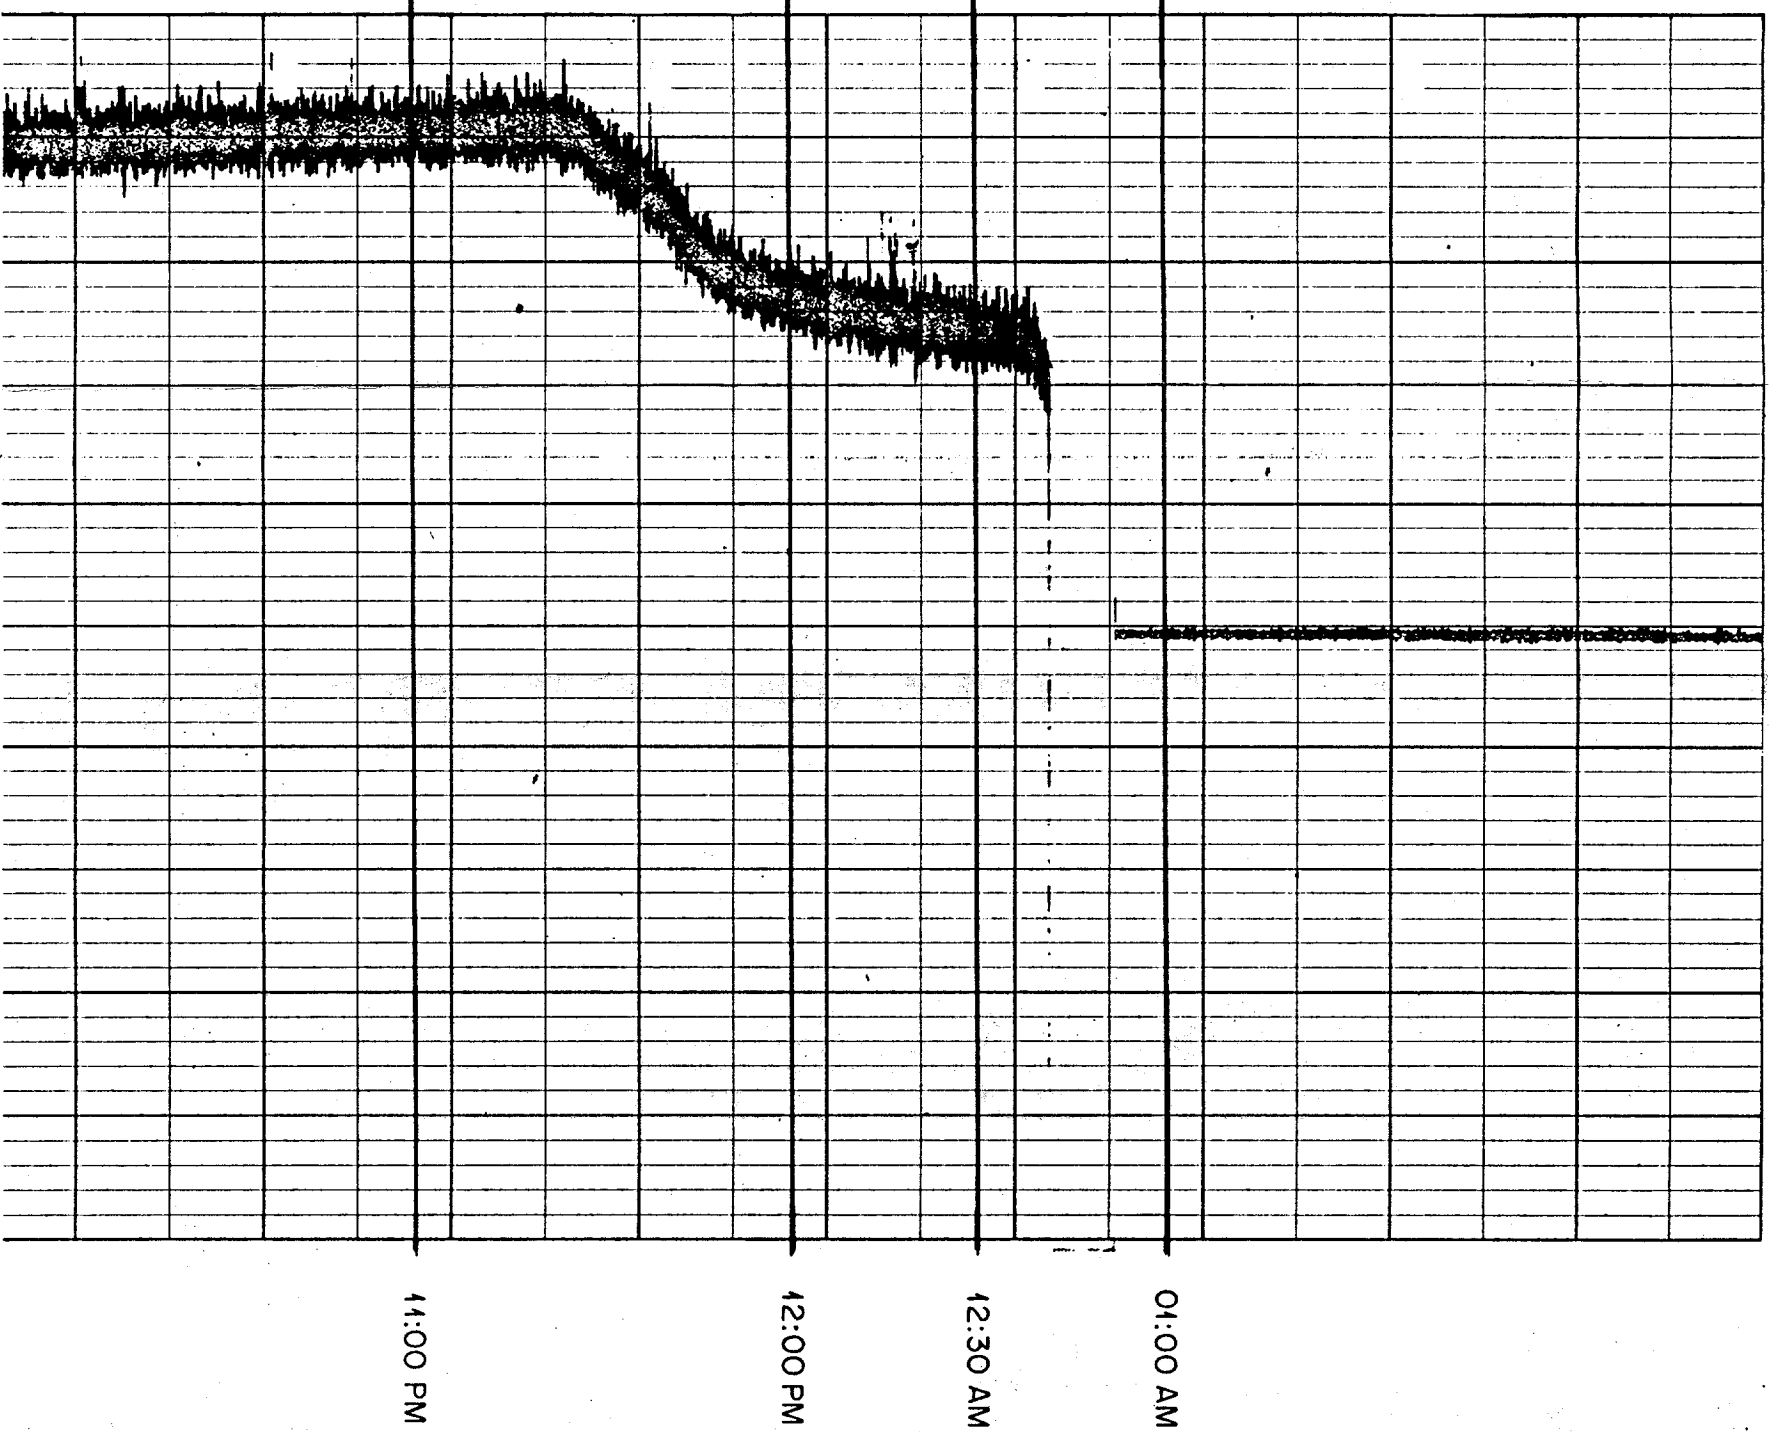
Fig. 4. Radioactivity Monitor Charts Synchronized with Rec

Available evidence tends to indicate that the release of fission products from the fuel element to the reactor coolant system was of short duration, probably less than 1 or 2 minutes, and that the major fraction of the release terminated prior to the reduction of reactor power from 24 Mw. These conclusions are drawn in part from Figure 4, a "synchronized" display of the recorder charts from the No. 1 safety channel (showing reactor power level); the reactor secondary water activity instrument channel (showing "shine" from the primary heat exchangers); the reactor water activity instrument channel (showing the

response of a radiation detector located adjacent to the reactor coolant system water line downstream from the primary heat exchangers); and the degasifier activity instrument channel. Estimated accuracy of the synchronization of the recorder charts is ± 1 minute. If appropriate correction factors, to account for the time lag between an event in the core and its detection by downstream radiation detectors, are applied to the response of these radiation instruments, one concludes that initiation of the release was very nearly coincident with the attainment of 24 Mw. Further, the response of the reactor water activity instrument, together with the behavior of the ^{16}N instrument (which returned "onscale" prior to reactor power reduction from 24 Mw), indicates that the release essentially terminated prior to the reduction of reactor power.

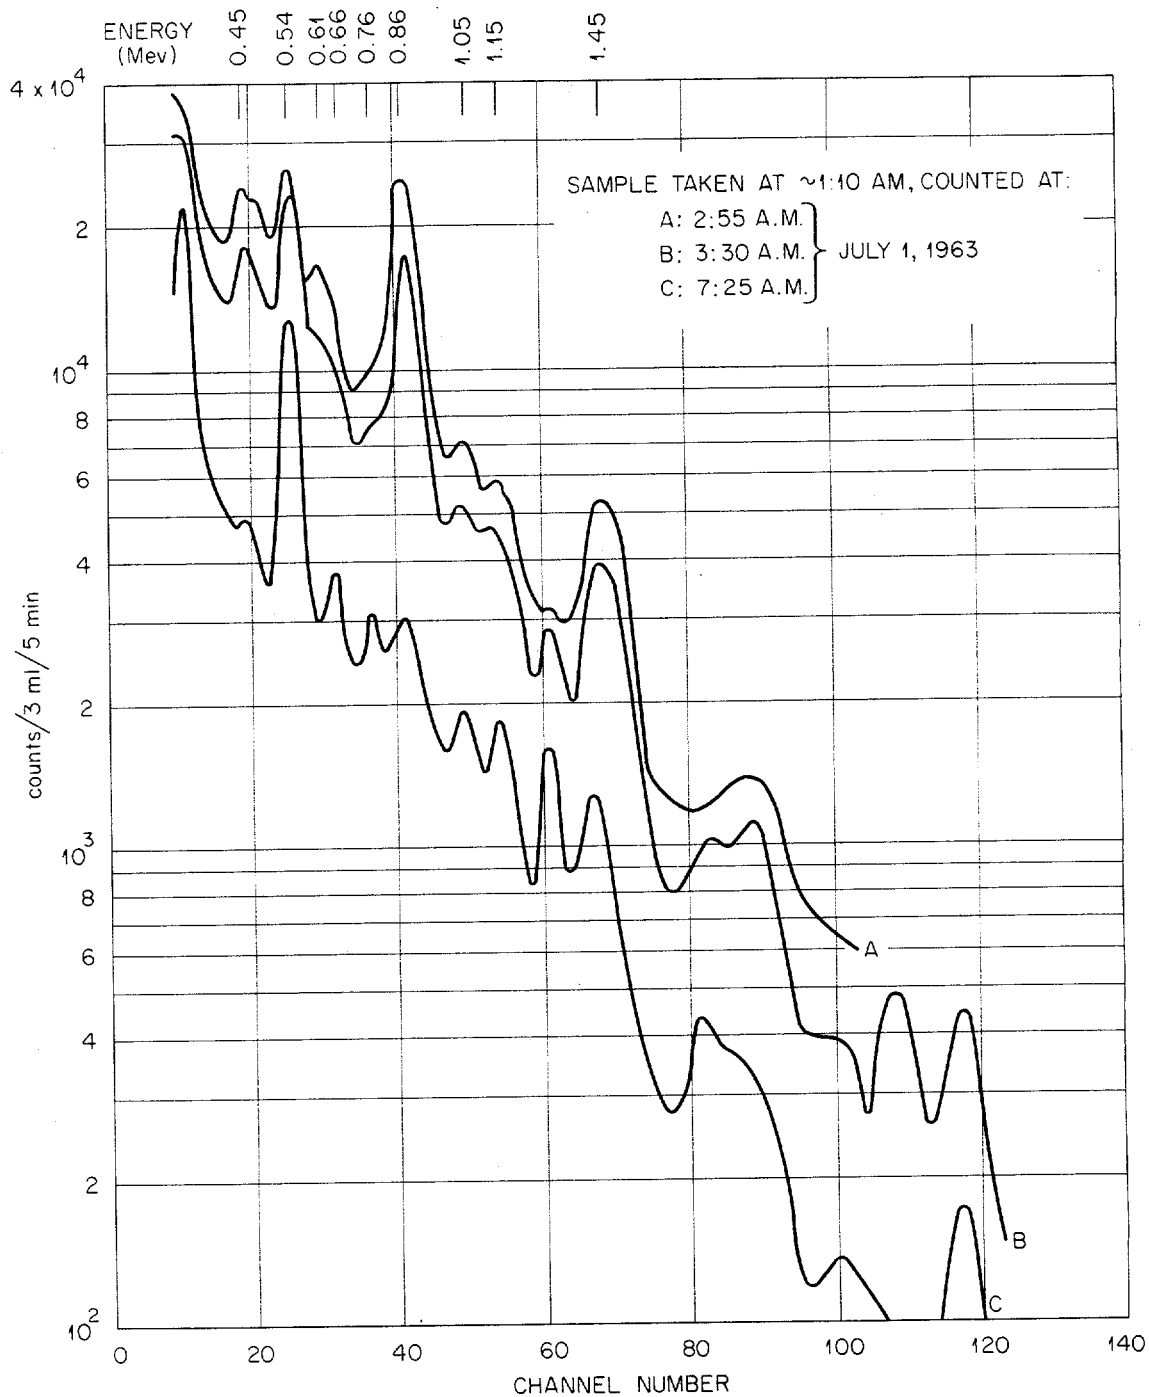
Fig. 5. γ -Spectra of a Reactor Water Sample

Preliminary estimates, based on the gross β - γ activity of a sample of the reactor water system taken at 1:10 AM and an estimated counter efficiency and geometry factor, indicate a total fission-product inventory of the order of 1000 curies in the coolant system one-half hour after the release. Analyses of reactor water system samples (Figures 5 and 6) on a gamma spectrometer indicated that the principal contaminants were 54-min ^{134}I , 21-hr ^{133}I , 6.7-hr ^{135}I , 32-min ^{138}Cs , and 2.8-hr ^{88}Kr . This, together with other observations subsequently discussed, indicates rather conclusively that only volatile fission products were released from the fuel element into the water in significant quantities. Radiation levels at the south reactor demineralizer anion column (on stream at the time of the release) reached ~ 20 r/hr (as compared to levels of ~ 100 - 200 mr/hr normally experienced at 30 Mw) further indicating that a significant portion of the contamination of the water system could be attributed to iodines. The recorded response of a radiation detector seeing "shine" from the column indicated that this radiation level was probably attained within 10 to 30 minutes after the release. Radiation levels at the pool demineralizer anion column reached ~ 400 mr/hr. This is of the order of 10 to 20 times the level normally encountered at 30 Mw. No significant increases in the radiation levels at the various demineralizer cation columns were observed.

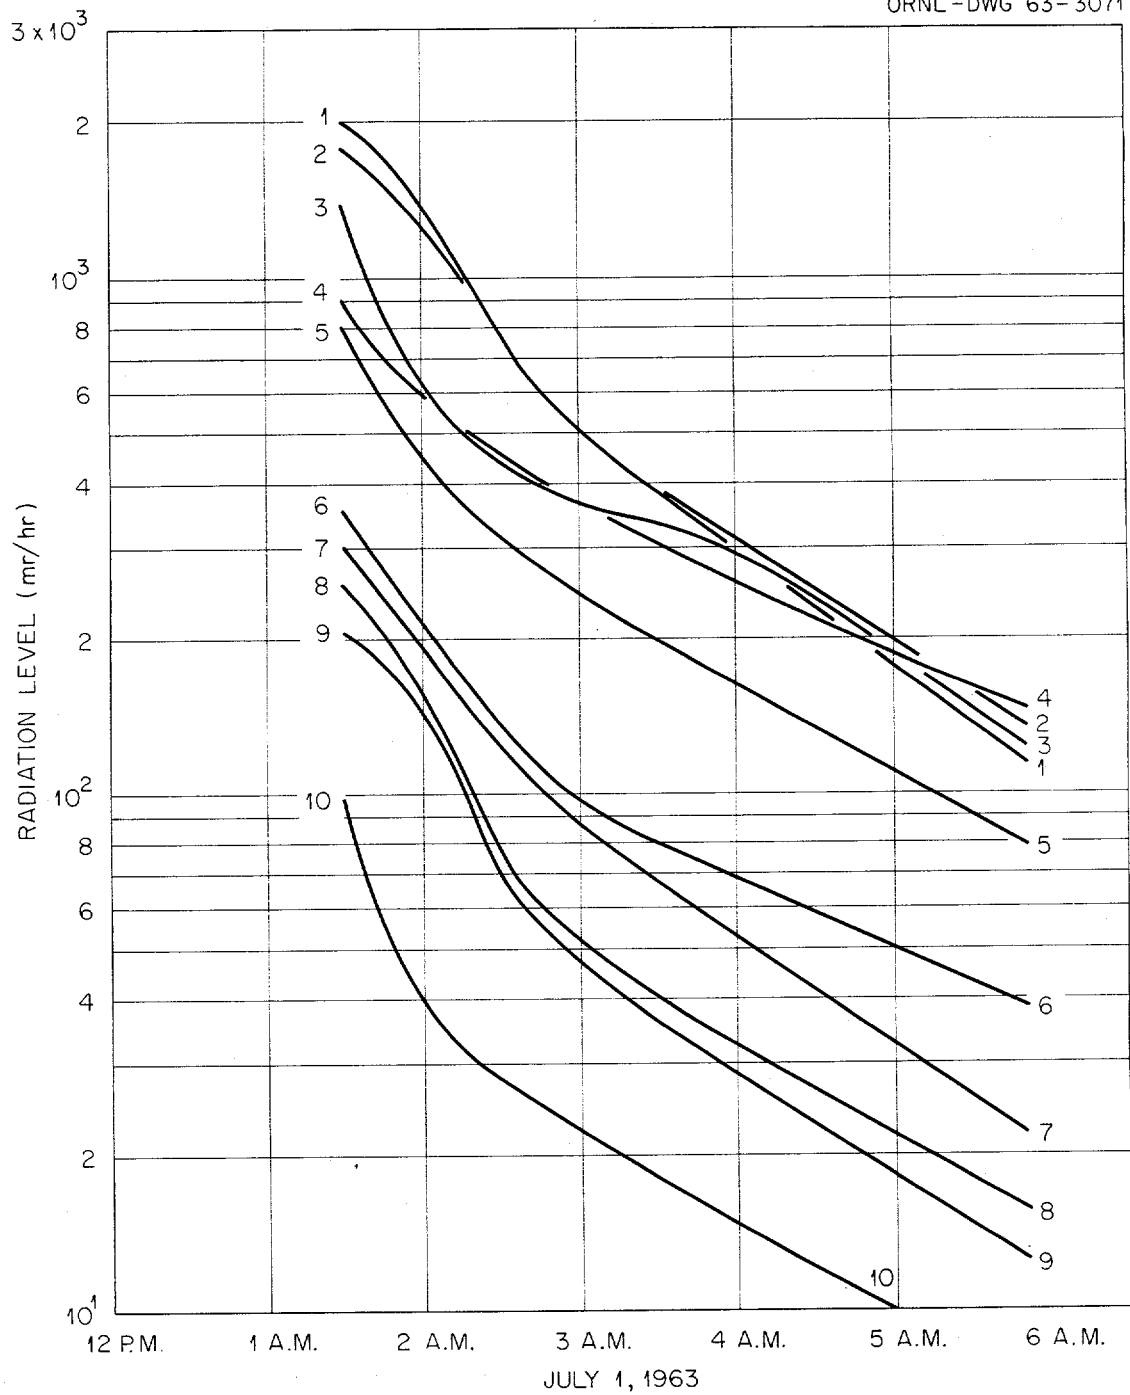
Fig. 7. Radiation Levels at Various Locations in the Reactor Coolant System

Radiation levels at various locations in the reactor primary coolant system outside the reactor building during the period from 1:30 AM to 5:15 AM, July 1, 1963, are shown in Figure 7 and Table 1. Figure 8 indicates the location of these components. Peak radiation levels measured were of the order of 10 to 20 times those normally encountered at 30 Mw.
